COMPREHENSIVE ASBESTOS AND LEAD-BASED PAINT XRF SURVEY REPORT

**COMPTON COMMUNITY COLLEGE
ADMINISTRATIVE BUILDING
1111 EAST ARTESIA BOULEVARD
COMPTON, CALIFORNIA 90221**

Bainbridge Project #: 18016255.12
January 18, 2018

RE: Phase 1 – Comprehensive Asbestos and Lead-Based Paint XRF Survey Report for Compton Community College – Administrative Building located at 1111 East Artesia Boulevard, Compton, California 90221.

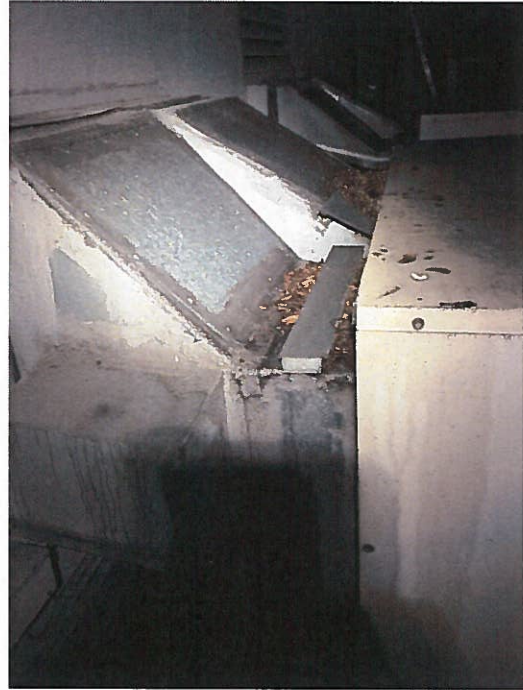
View of Ducting Mastic

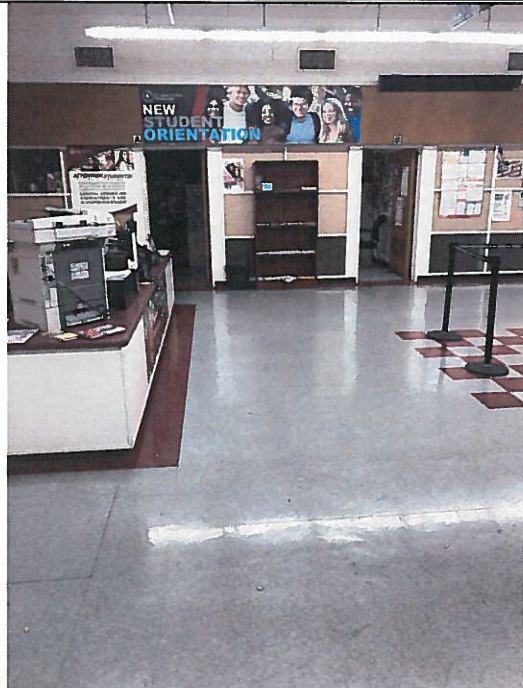
12"x 12" Red and Light Blue w/Streaks Floor Tile in Reception Lobby

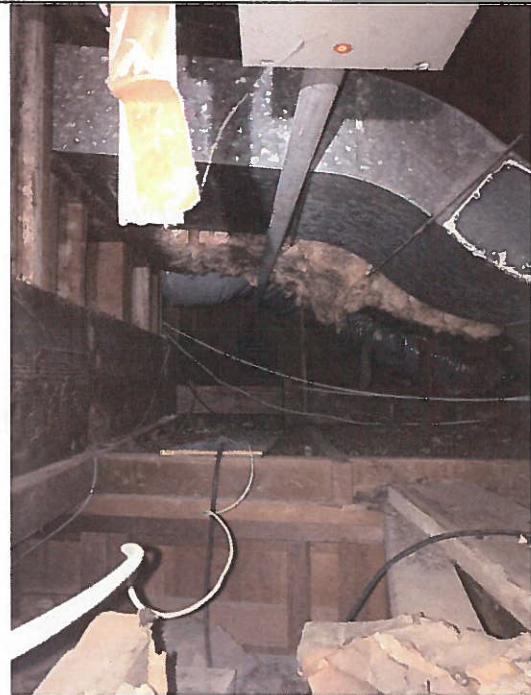
Attic

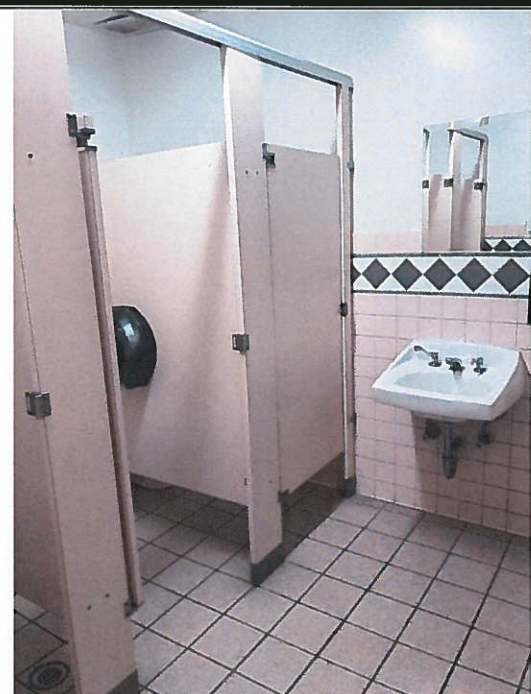
Men's Restroom
